**Final Report:**  
**Monitoring Protocol and Data Collection:**  
*Comparison of the Runoff Water Quantity, Quality and  
Thermal Performances of Two Green Roof Technologies;  
Thin vs. Thick*

University of Pittsburgh Project Number 703543

**August 2009**

Prepared for: Three Rivers Wet Weather  
Sub Grant # 03-01-GRM  
Pittsburgh, Pennsylvania

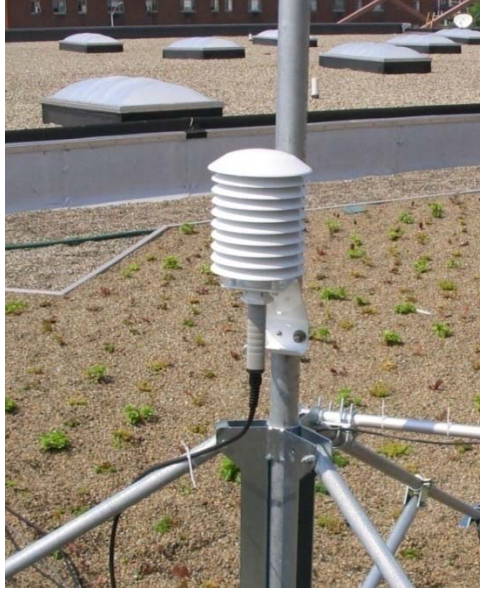
**Figure 3-3 Relative humidity sensor for recording ambient air temperature and relative humidity in radiation shield (Giant Eagle)**

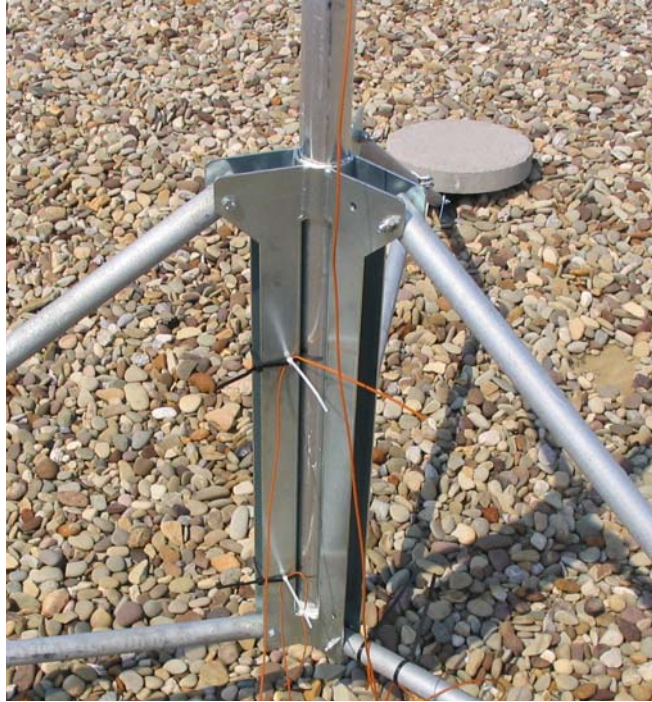
**Figure 3-4 Thermocouple wire for temperature monitoring Attached to Tripod (Giant Eagle)**

The 107 Temperature Probes can have lead lengths up to 1000 feet. Precautions must be taken in electronically “noisy” environments. AC power lines can affect the measurements. A 60 MHz rejection filter should be used if the probe is in an electronically noisy environment. The maintenance requirements for the temperature probes are minimal. The radiation shield was checked monthly for debris. Calibration was not needed after the instruments are set up. Thermocouple wire was purchased from Omega and was installed as shown in Figure 3-4.

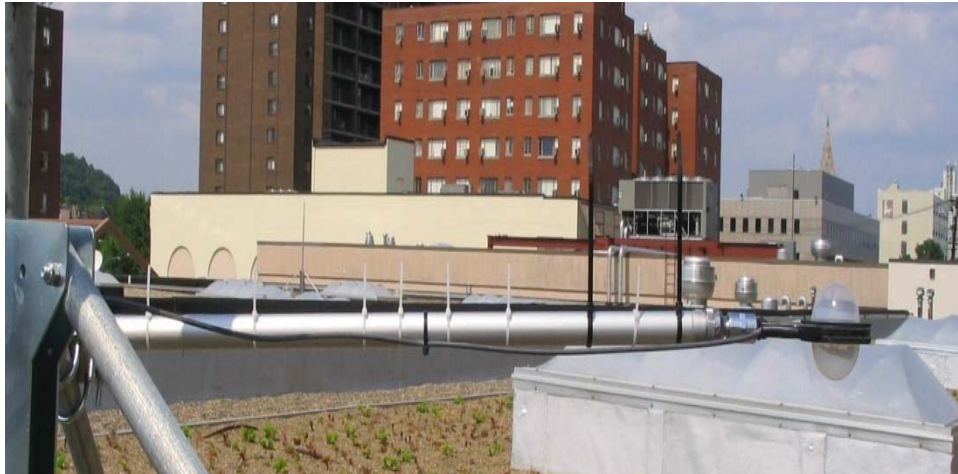
**Figure 3-5 Net radiometer for measuring net radiation at the roof surface (Giant Eagle)**

color. If it turns pink, the gel needs to be replaced which occurs commonly in wet weather. Condensation on the wind shield can block the long-wave radiation reading. An RV2 ventilator was installed per recommendation of the vendor to prevent condensation. The windshields was inspected often and cleaned as needed with distilled water, and replaced on a regular schedule (every 3-6 months). A series of wire ties were used to keep birds from standing on the long arm of the sensor since that part was particularly fragile.

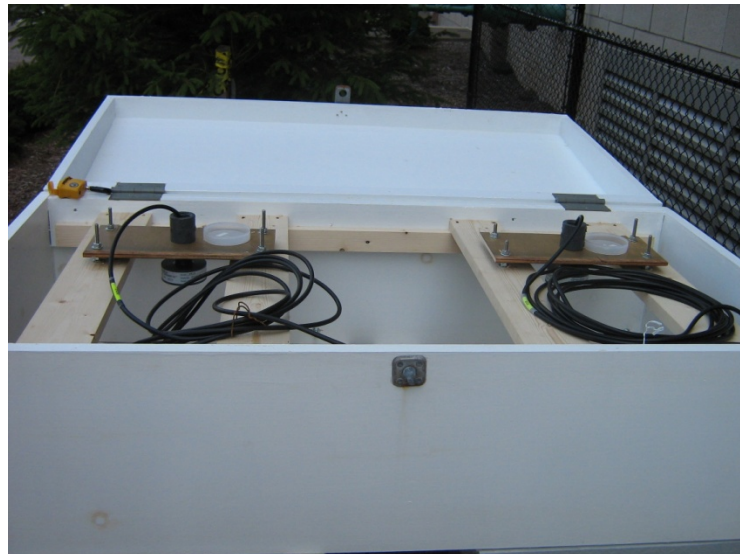
**Figure 3-9 Ultrasonic sensors installed atop the flumes for measuring stormwater runoff (Giant Eagle)**

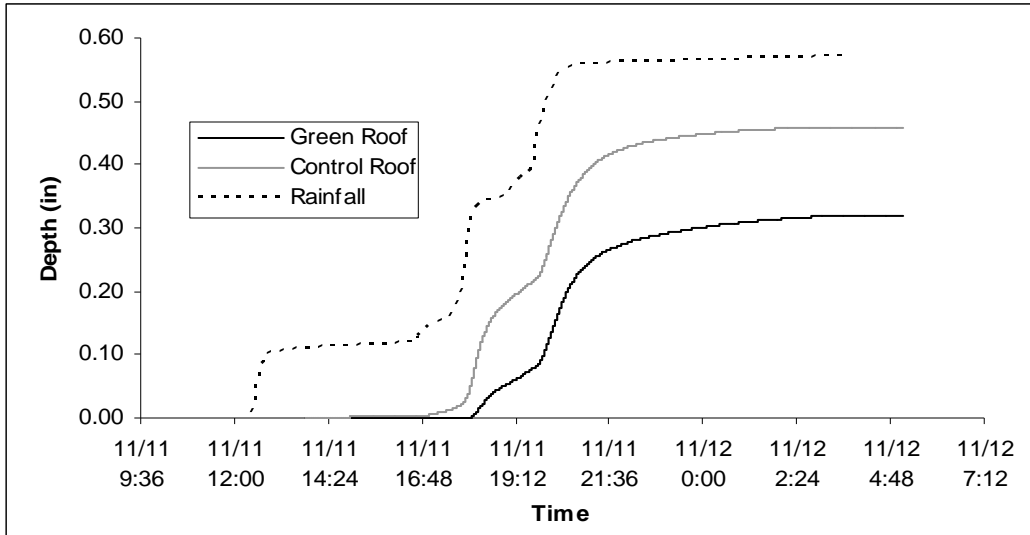
**Figure 4-1 Runoff as Rainfall - November 11, 2006 Storm**

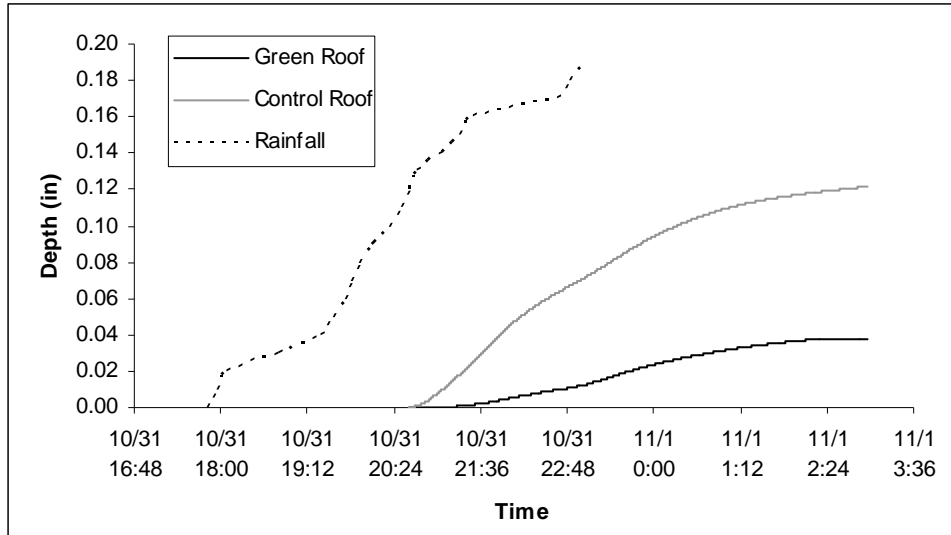
Figure 4-5 Runoff as Rainfall - October 31, 2006 Storm

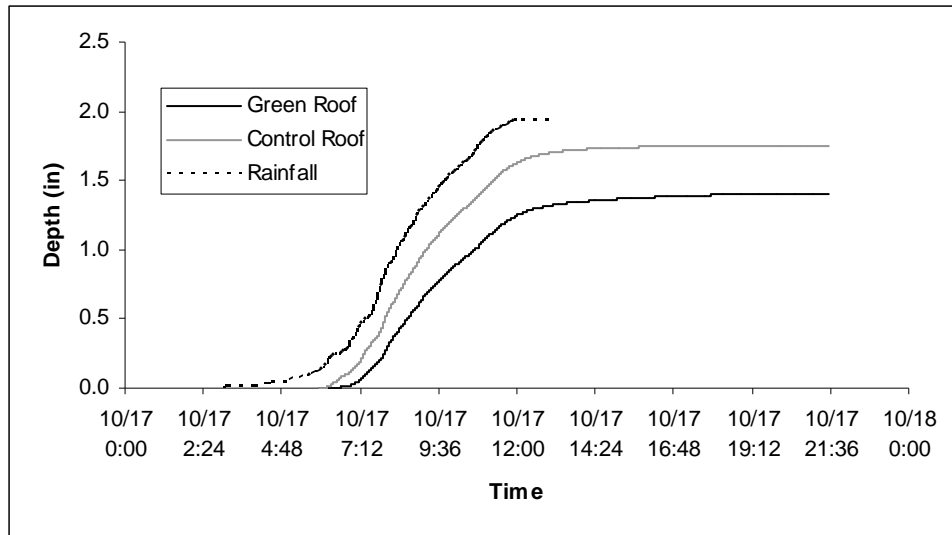
Figure 4-10 Runoff as Rainfall - October 17, 2006 Storm

This was the first storm that occurred after the irrigation system was turned off for the winter and soil moisture content data was measured. The volumetric water soil moisture content for two locations on the green roof is shown in Figure 4-14. At the start of the storm, both locations had an identical water content of 16 percent by volume. Water content reached a maximum at 20.6% at location A and 19% at location B at approximately the same time the green roof reached its peak runoff flow rate. The water content began to steadily decline at the point most of the rain had stopped falling, eventually reaching values of 18 and 17% water by volume by the time runoff stopped flowing from the green roof.

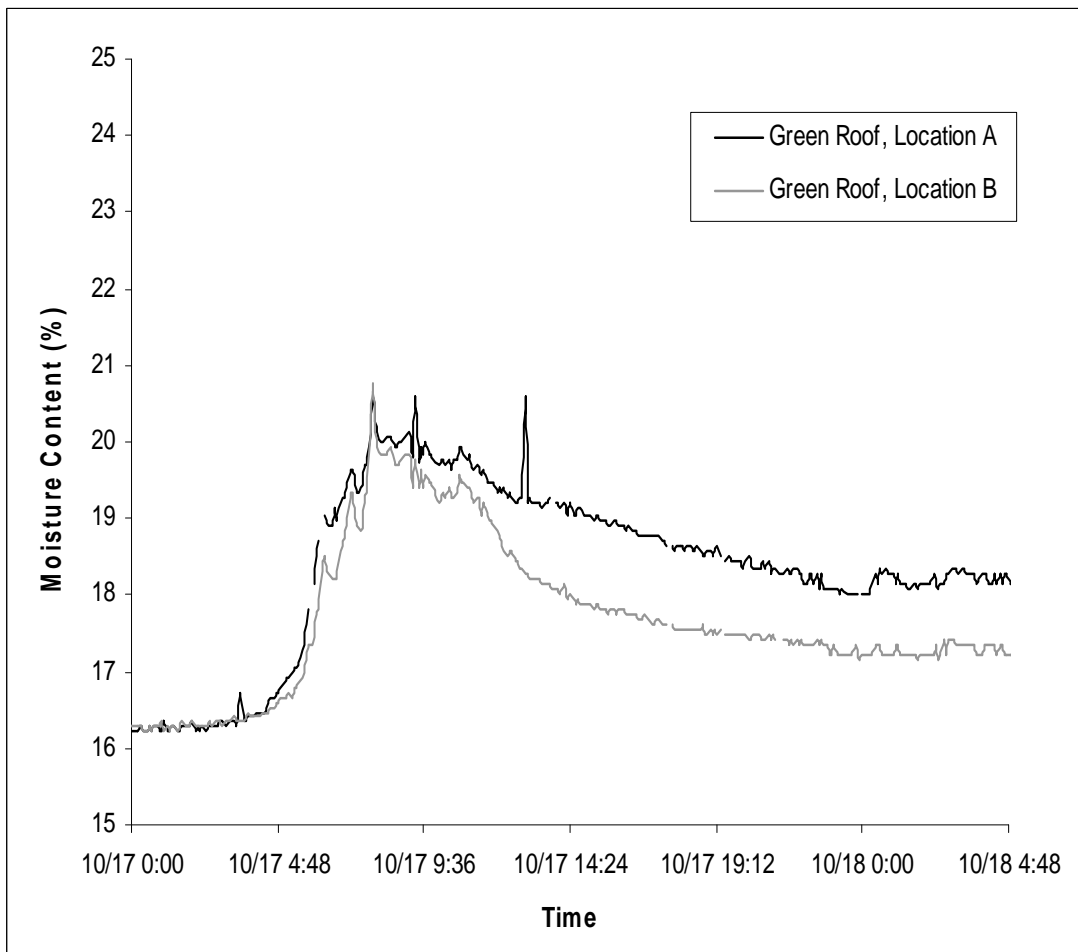
**Figure 4-14 Green Roof Moisture Content - October 17, 2006 Storm**

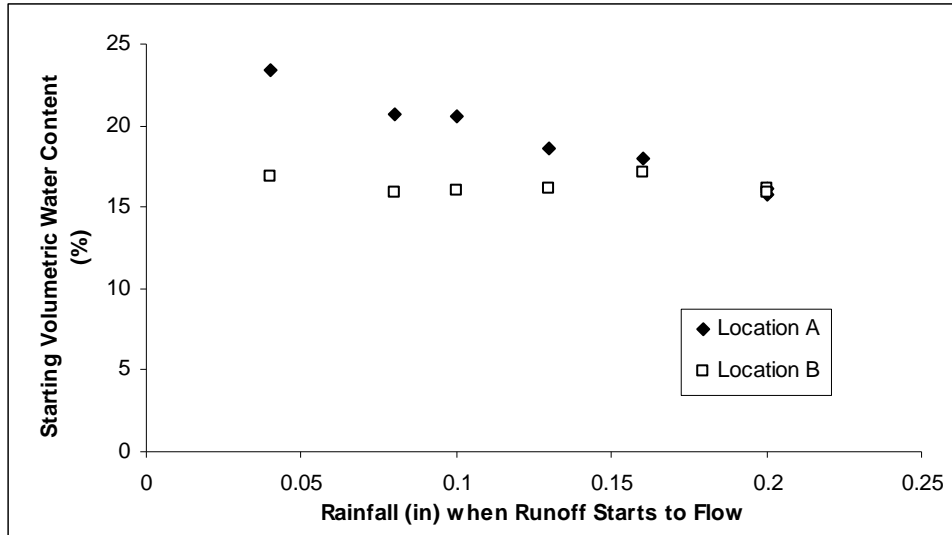
**Figure 4-15 Soil Water Content versus Rainfall Depth at the Start of Runoff Flow**

The clearest relationship between water content and runoff is water content in relation to the point when runoff begins to flow. Figure 4-15 shows a plot of the volumetric water content just before the start of each storm versus the depth of rainfall that fell before runoff began to flow from the green roof. Both measurement locations are shown in Figure 4-15, but location A is the most important because measurement point is situated a few feet from the green roof drain where runoff measurements are recorded. Figure 4-15 indicates that the green roof retained more rainwater when the substrate is drier. Dry soil has more void spaces available to absorb water. Results presented in the graph show all storms with available data from October 17, 2006 through the end of 2006 These storms all produced runoff after approximately 0.1 inches of rain fell, at starting volumetric water contents of 14 to 19 percent. As mentioned earlier, during this time period temperatures were often below freezing, including periods of snow accumulation, which likely affected the results that contrast the earlier data.
